Expanded Site Inspection  
Final Report

Avenue O and 118th Street  
Chicago, Illinois  
ILD 981 194 087

December 1996

Prepared for:  
U.S. Environmental Protection Agency  
under Alternative Remedial Contracting Strategy (ARCS)  
Contract 68-W8-0064, Work Assignment 33-5JZZ  
ARCS Contractor Project 71280.102

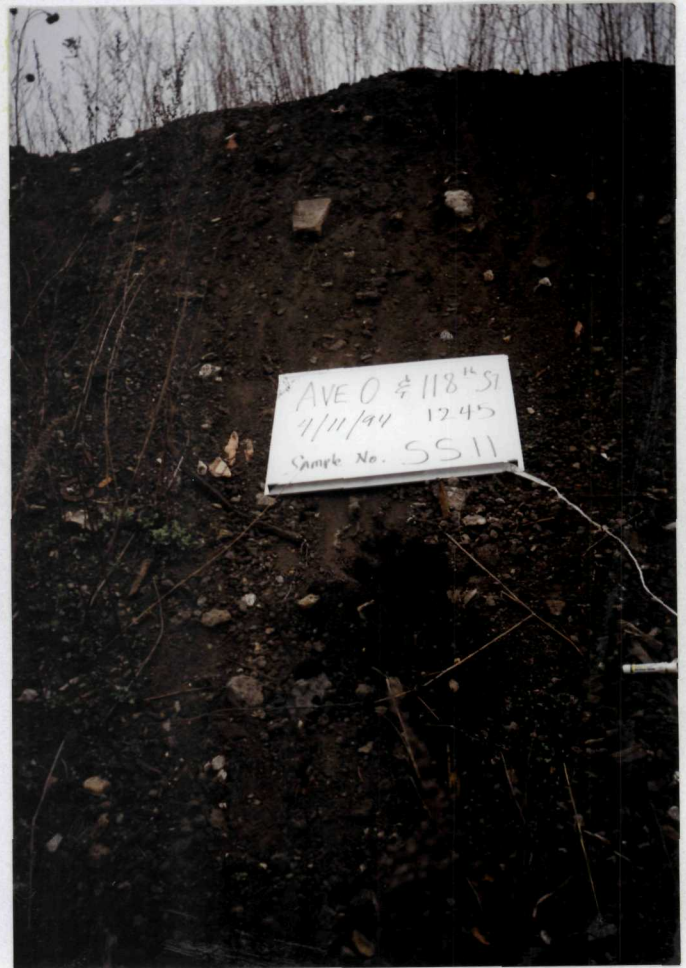
Site: Avenue O and 118th Street  
Proj. #: 71280.102  
Roll: 1 Photo #: 1  
Date: 4-11-94 Time: 1245  
Description: Photo taken facing south showing a close-up of the SS11 sample location. SS11 was collected from west end of the continuous dirt embankment that runs along the southeastern site perimeter.

Soil samples SS11, SS12, SS13, and SS14, collected from the continuous soil embankment that runs along the southeastern and eastern site boundaries, contained hazardous substances in concentrations that meet observed release criteria. Soil sample SS11 contains one semivolatile organic compound at 5.6 mg/kg and three metals ranging from 16.6 to 633 mg/kg. SS12 contains two metals at 276 and 31,100 mg/kg; SS13 contains a metal at 166 mg/kg; and SS14 contains two semivolatiles at 1.3 and 2.8 mg/kg, one polychlorinated biphenyl compound at 1.6 mg/kg, and one metal at 170 mg/kg.

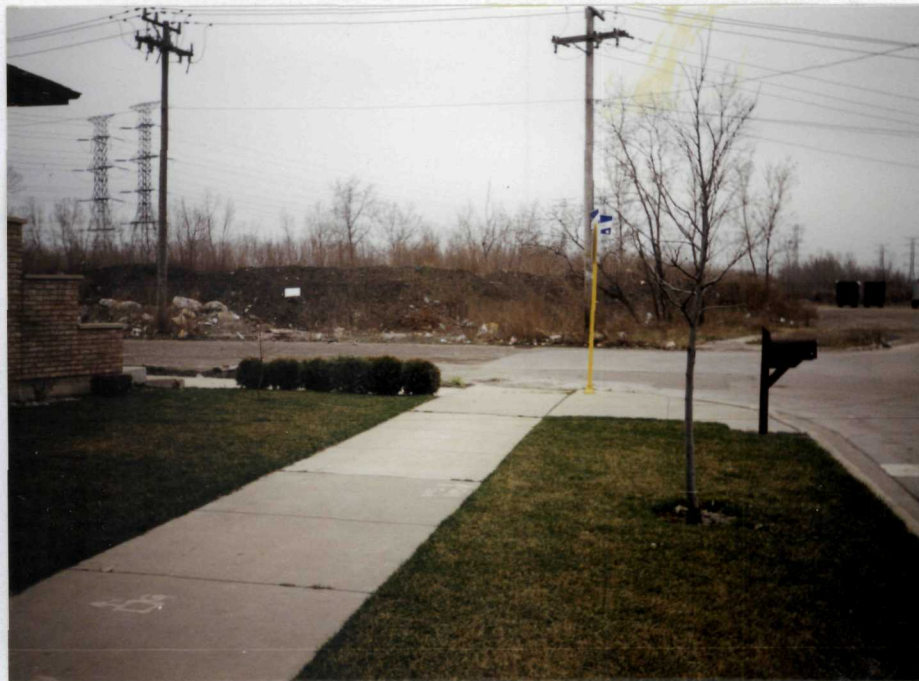
Site: Avenue O and 118th Street  
Proj. #: 71280.102  
Roll: 1 Photo #: 2  
Date: 4-11-94 Time: 1246  
Description: Photo taken facing south from a residential sidewalk area at the northeastern quadrant of the intersection of Ewing Avenue and 118th Street. The photo shows the approximately 5-foot-tall dirt embankment, along the southeastern corner of the intersection of Ewing and 118th Street, from which SS11 was collected.

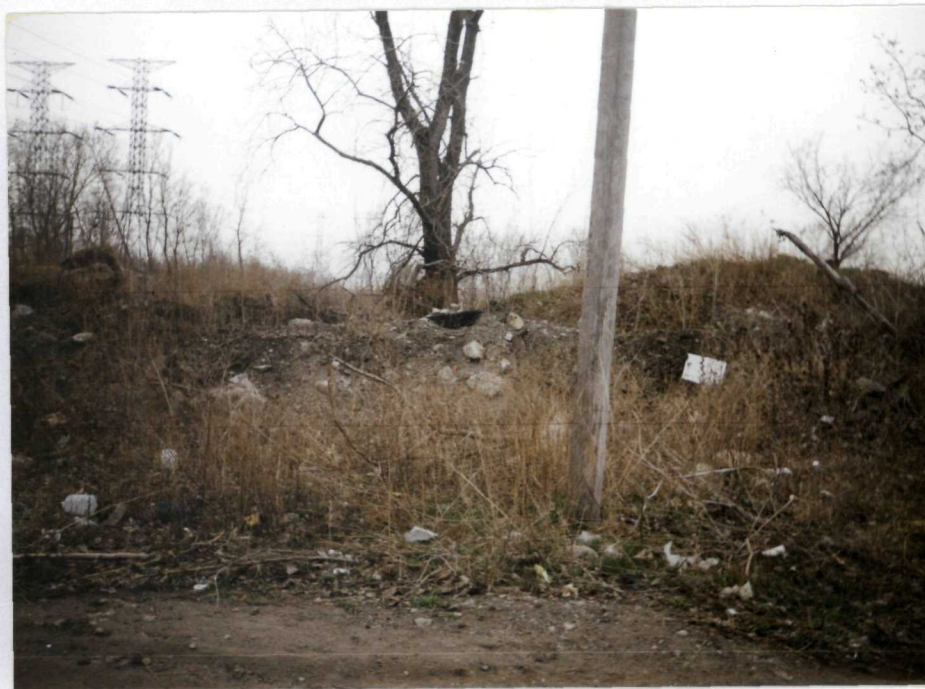
Description: Photo taken facing south, showing the dirt embankment where sample SS12 was collected. There is a telephone pole in the foreground of the photo and a tree and high-voltage electrical power-line support structures in the background.

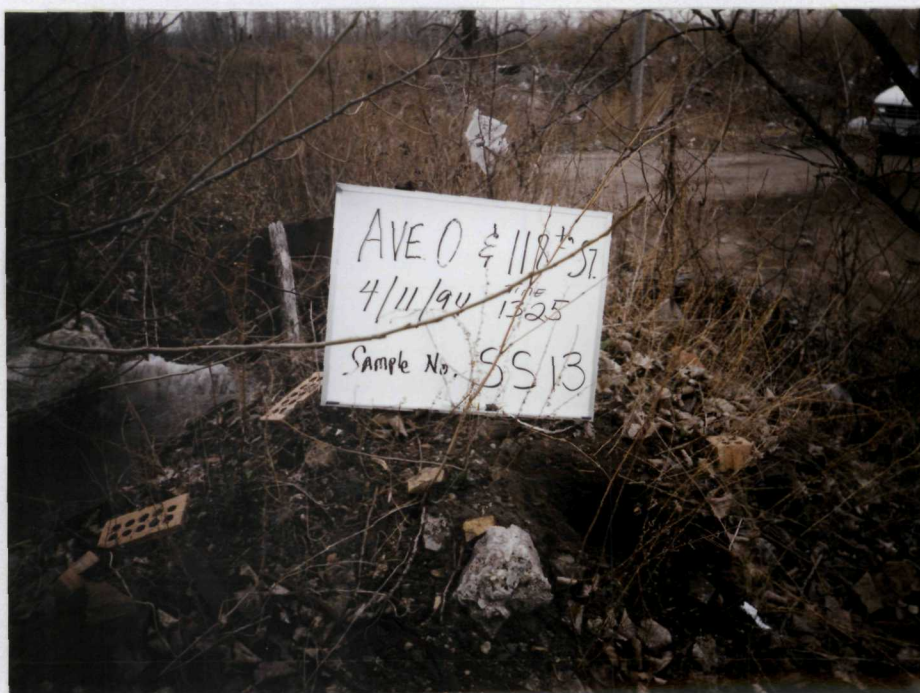
Description: Photo taken facing southwest, showing the SS13 sample location. There are rocks, bricks, and other debris visible in the foreground of the photo.

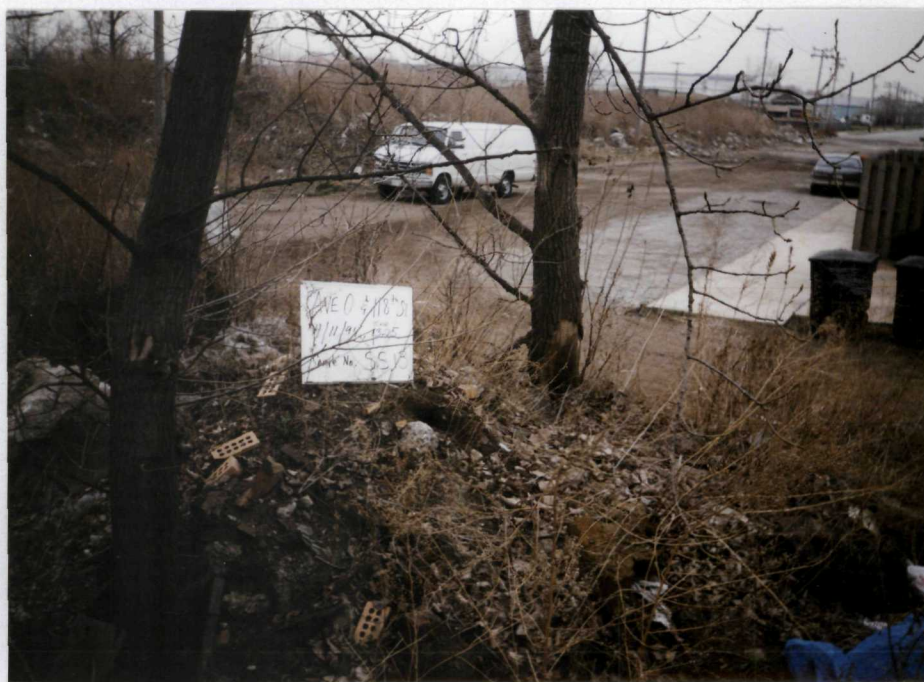
Description: Photo taken facing southwest showing the area where SS13 was collected. There are two trees in the photo, one just east of the SS13 location and the other just west. The eastern end of 118th Street is shown in the background with a white van parked on the south side of 118th Street.

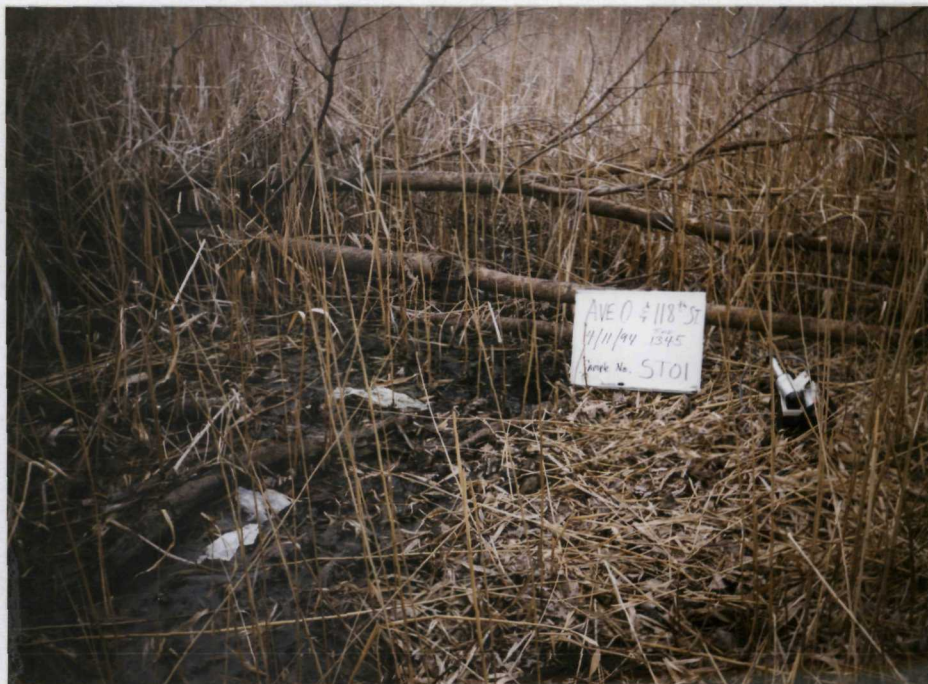
Site: Avenue O and 118th Street  
 Proj. #: 71280.102  
 Roll: 1 Photo #: 7  
 Date: 4-11-94 Time: 1346  
 Description: Photo taken facing east, showing the marshy area where ST01 was collected. There are a few fallen trees, tall dried grass, and an air monitoring instrument visible in the photo.

Sediment samples ST01 and ST02 were collected from the wetlands area east of the Avenue O site. ST01 contains three metals and ST02 contains one semivolatile organic compound and two metals, all meet observed release criteria.

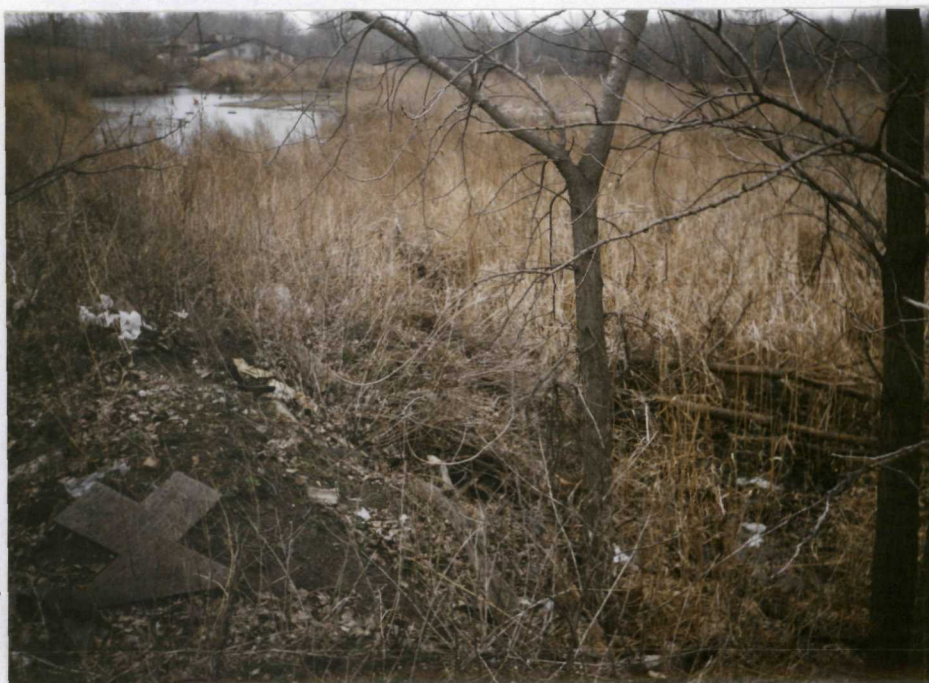
Site: Avenue O and 118th Street  
 Proj. #: 71280.102  
 Roll: 1 Photo #: 8  
 Date: 4-11-94 Time: 1348  
 Description: Photo taken facing northeast, standing south of the wetlands that exists east of the site, showing the swampy area where sample ST01 was collected.

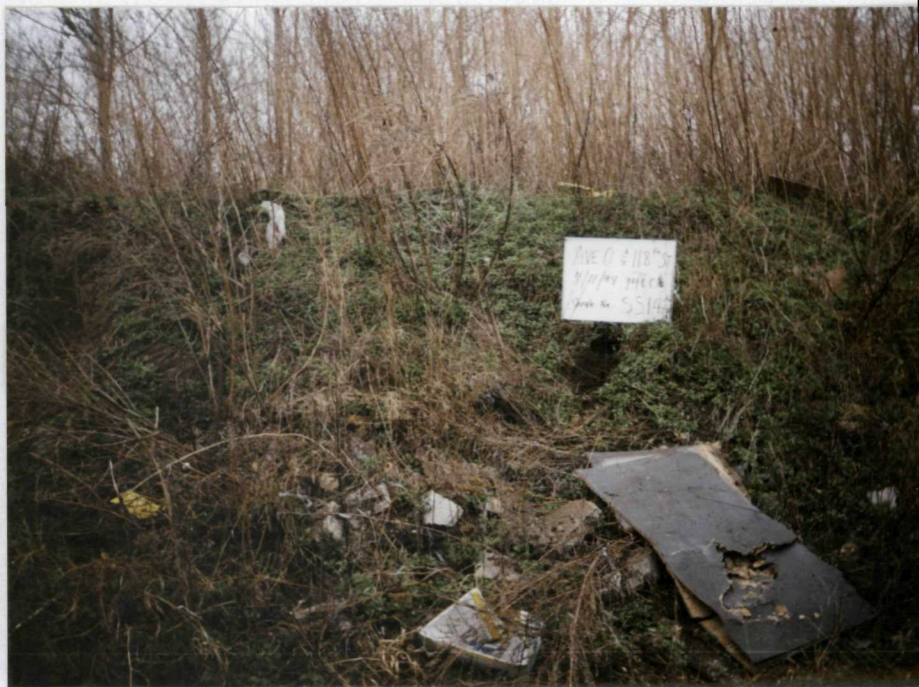
Site: Avenue O and 118th Street  
Proj. #: 71280.102  
Roll: 1 Photo #: 9  
Date: 4-11-94 Time: 1400  
Description: Photo taken facing east,  
showing the SS14 location. SS14 was  
collected from the northern portion of the dirt  
embankment that runs along Avenue H. This  
part of the embankment is slightly vegetated  
and there is some solid waste articles in the  
foreground of the photo.

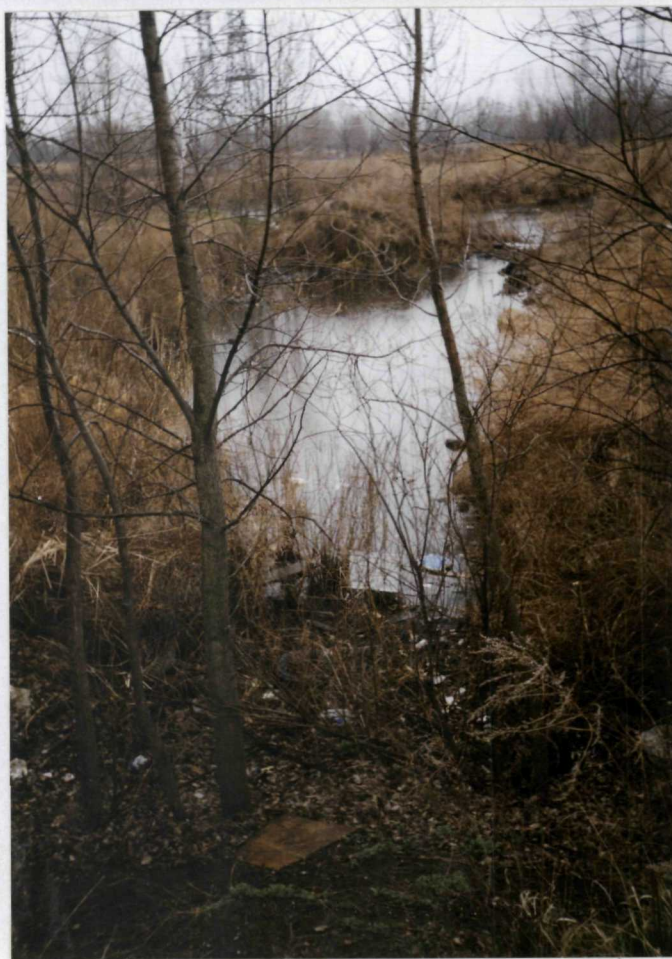
Site: Avenue O and 118th Street  
Proj. #: 71280.102  
Roll: 1 Photo #: 10  
Date: 4-11-94 Time: 1420  
Description: Photo taken facing south,  
showing the wetlands area (includes a pond)  
where ST02 was collected. ST02 was collected  
from the north side of the pond located in the  
wetlands just east of the portion of the site's  
boundary that runs along Avenue H.

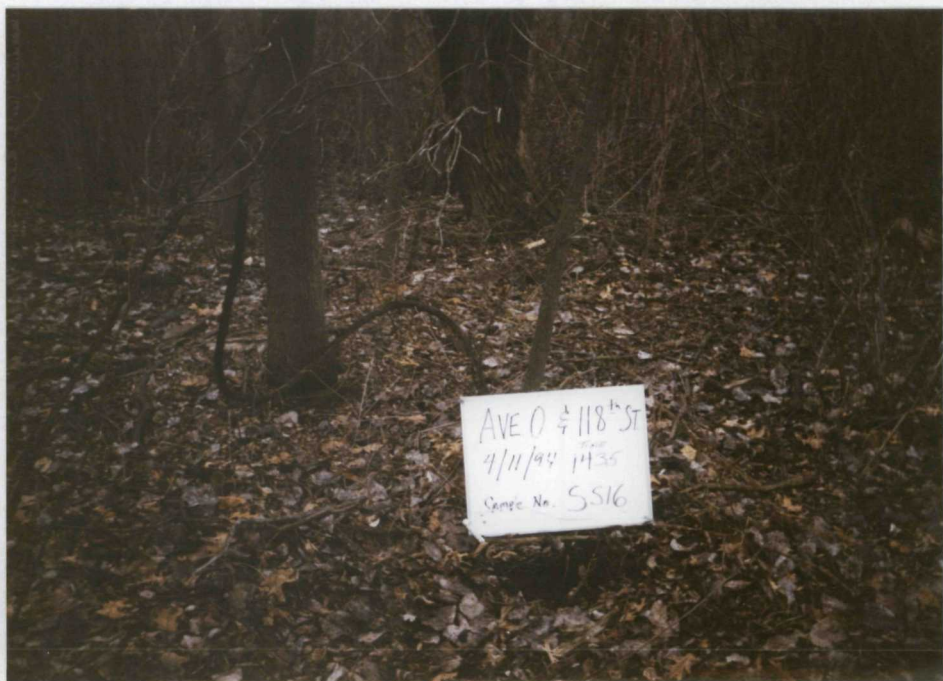
Site: Avenue O and 118th Street  
 Proj. #: 71280.102  
 Roll: 1 Photo #: 12  
 Date: 4-11-94 Time: 1435  
 Description: Photo taken facing west,  
 showing the wooded area within the Eggers  
 Woods Forest Preserve, where background  
 soil sample SS16 was collected.

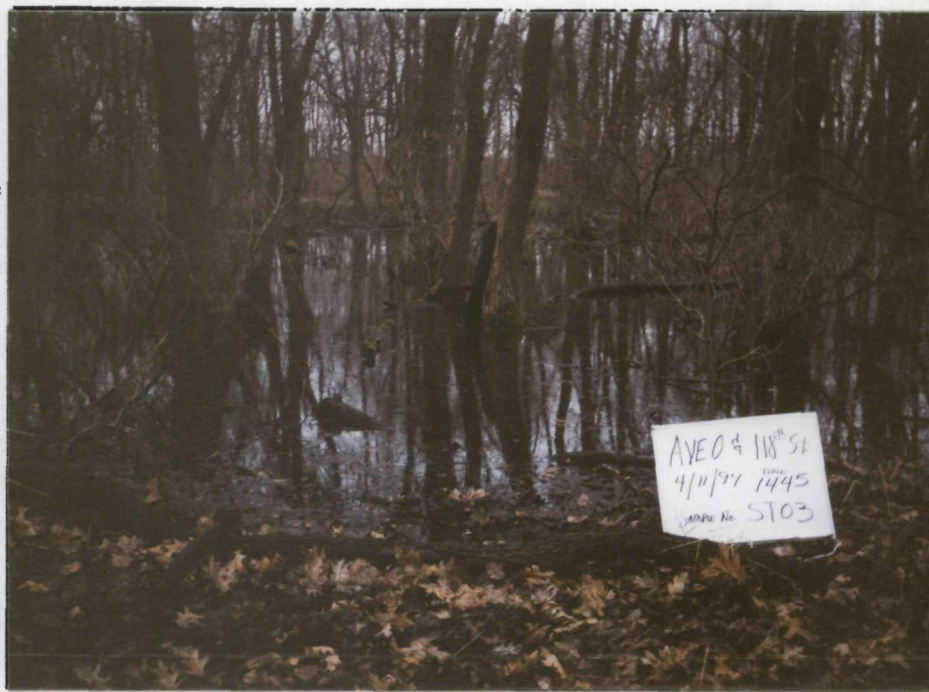
Site: Avenue O and 118th Street  
Proj. #: 71280.102  
Roll: 1 Photo #: 13  
Date: 4-11-94 Time: 1445  
Description: Photo taken facing east,  
showing the swampy wetlands area within the  
Eggers Woods Forest Preserve, where the  
background sediment sample ST03 was  
collected.

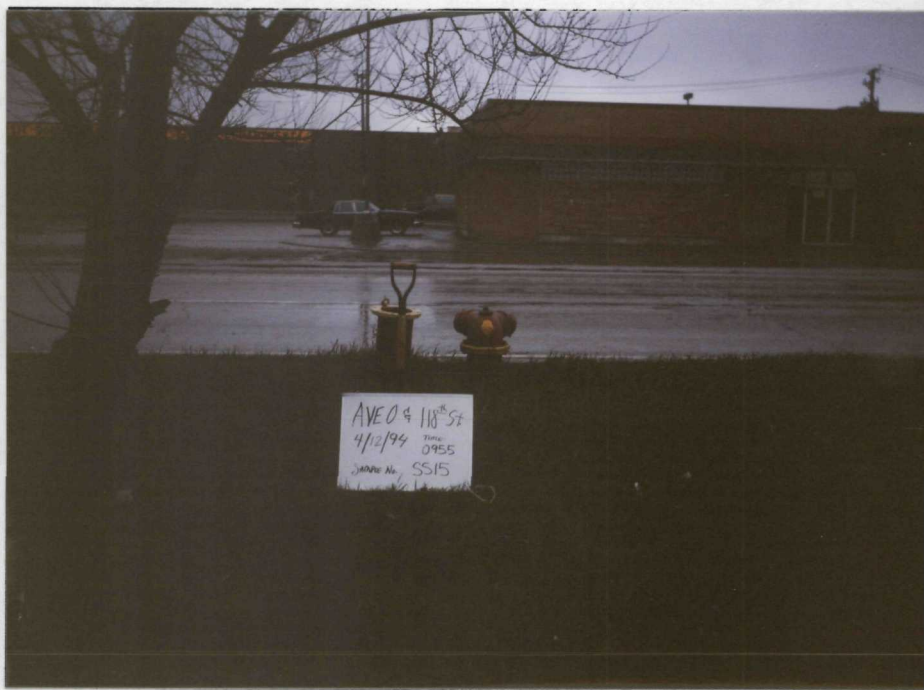
Site: Avenue O and 118th Street  
Proj. #: 71280.102  
Roll: 1 Photo #: 15  
Date: 4-12-94 Time: 0955  
Description: Photo taken facing east, showing the grassy area on the west side of Avenue O where background soil sample SS15 was collected. There is a tree on the left side of the photo, a fire hydrant in the center foreground, and Avenue O and the west side of the small shopping mall on the east side of Avenue O is shown in the background.

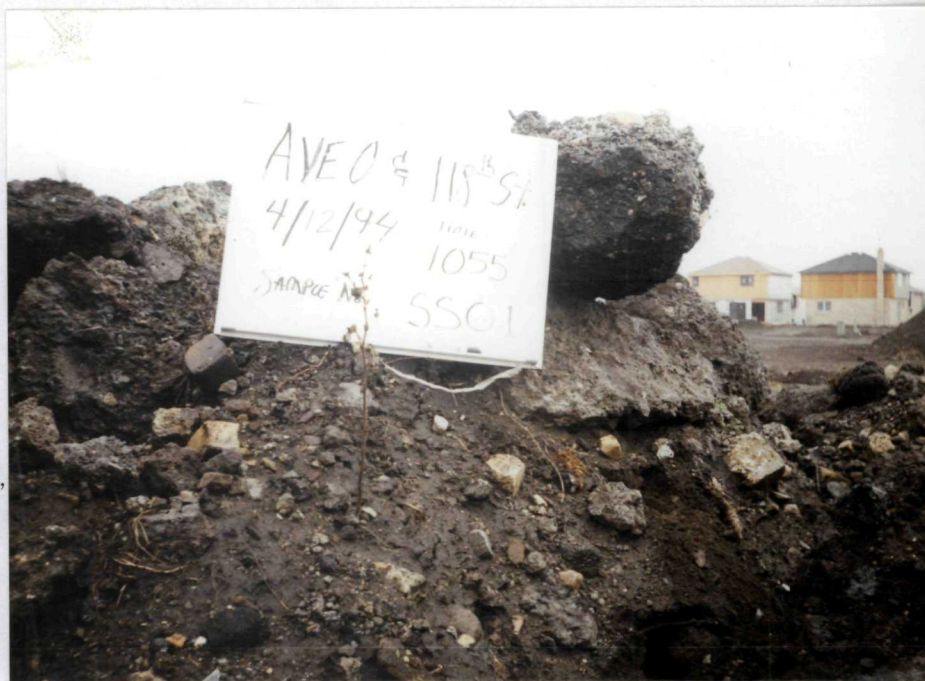
Description: Photo taken facing northeast, showing a close-up of the dirt and rubble pile that sample SS01 was collected from.

Soil sample SS01 was collected from the excavated soil pile in the northwestern quadrant of the site. SS01 contains eight semivolatile organic compounds ranging from 2.3 to 19 milligrams per kilogram (mg/kg) that meet observed release criteria.

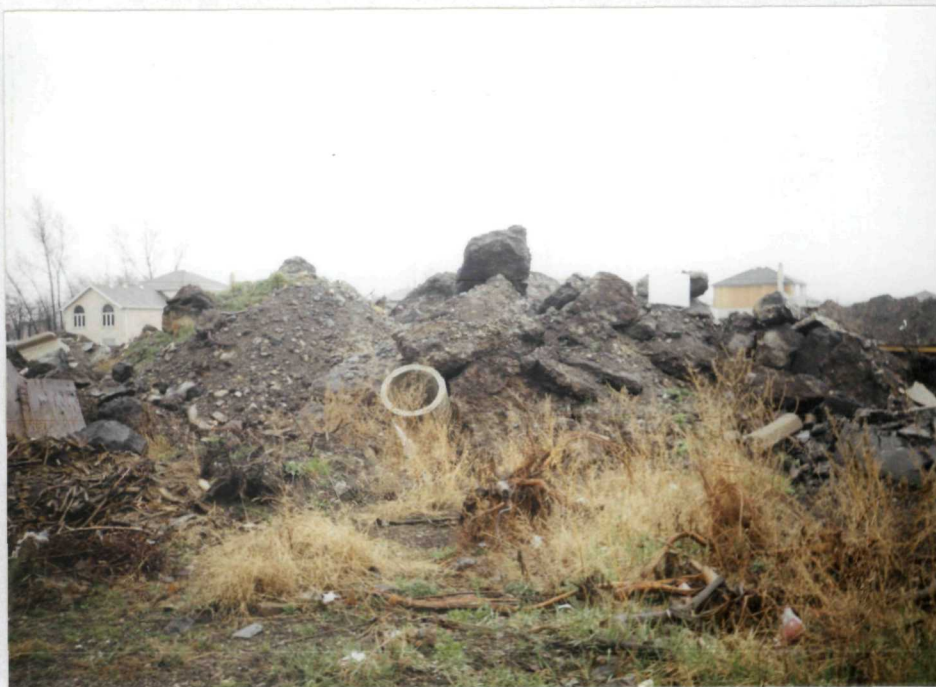
Site: Avenue O and 118th Street  
 Proj. #: 71280.102  
 Roll: 1 Photo #: 19  
 Date: 4-12-94 Time: 1056  
 Description: Photo taken facing east/northeast, showing the dirt and rubble pile, laced with construction debris, where sample SS01 was collected. There are newly constructed houses in the background.

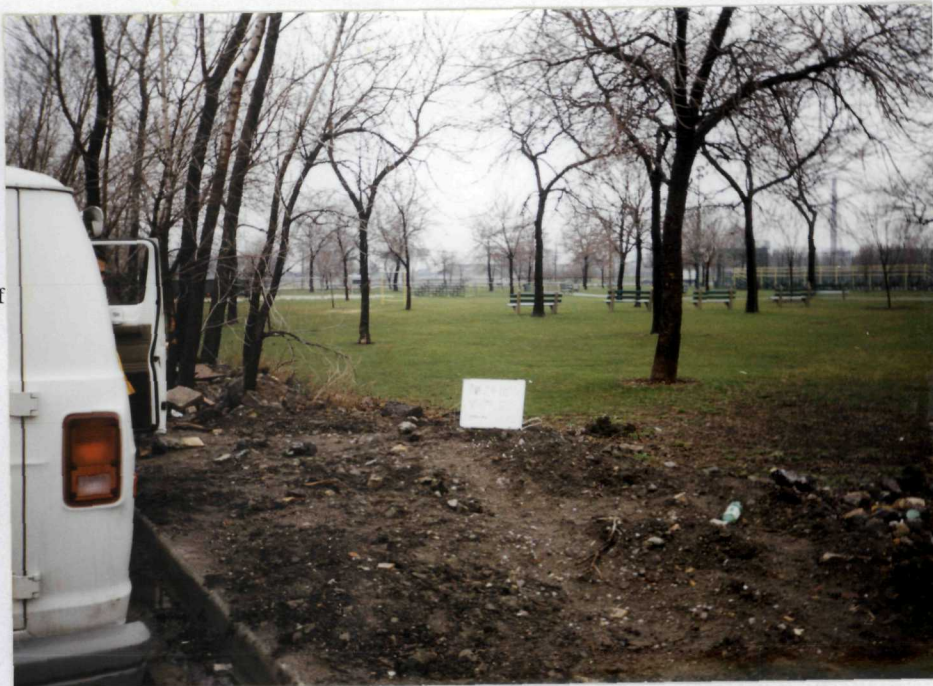
Site: Avenue O and 118th Street  
 Proj. #: 71280.102  
 Roll: 1 Photo #: 21  
 Date: 4-12-94 Time: 1121  
 Description: Photo taken facing northwest, showing the SS02 sample location. Rowan Park (with park benches and trees) is visible in the background and the right side of the rear end of a white van is on the left.

Soil sample SS02 was collected from the north shoulder of 116th Street, near the northwestern intersection of Avenue M and 116th Street, in an unpaved area with soil/debris. SS02 contains a semivolatile organic compound at 1.3 mg/kg that meets observed release criteria.

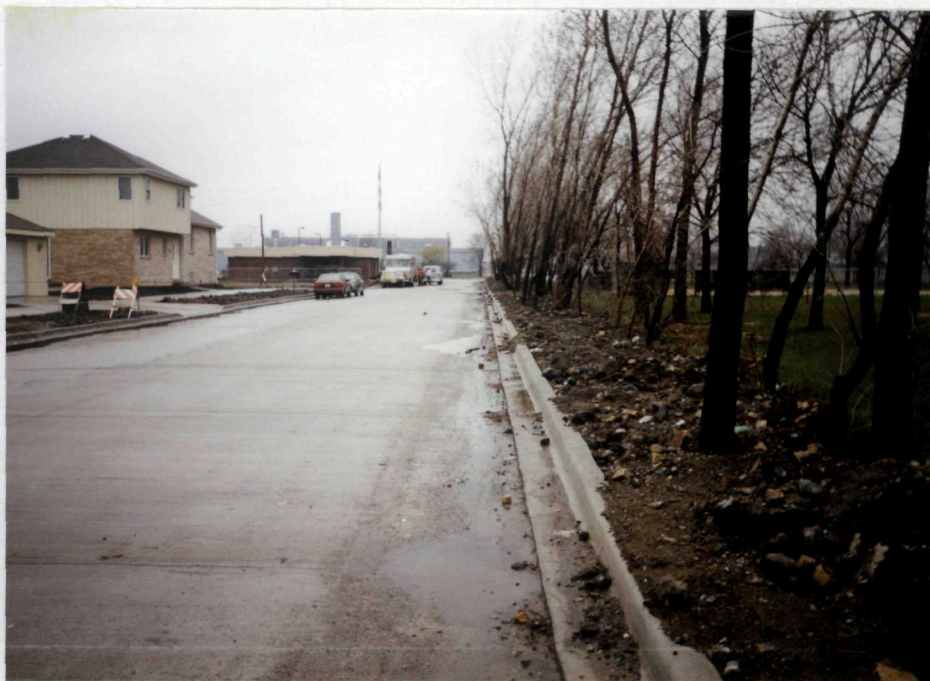
Site: Avenue O and 118th Street  
 Proj. #: 71280.102  
 Roll: 1 Photo #: 22  
 Date: 4-12-94 Time: 1122  
 Description: Photo taken facing west, from a standing point on the north side of 116th Street, just west of the SS02 sample location, showing a newly paved section of 116th Street. There is a continuous row of soil with rocks and debris along the north side of the road's curb/shoulder. Newly constructed homes, vehicles parked in the street, and the bank at the SE corner of Avenue O and 116th Street are visible in the background.

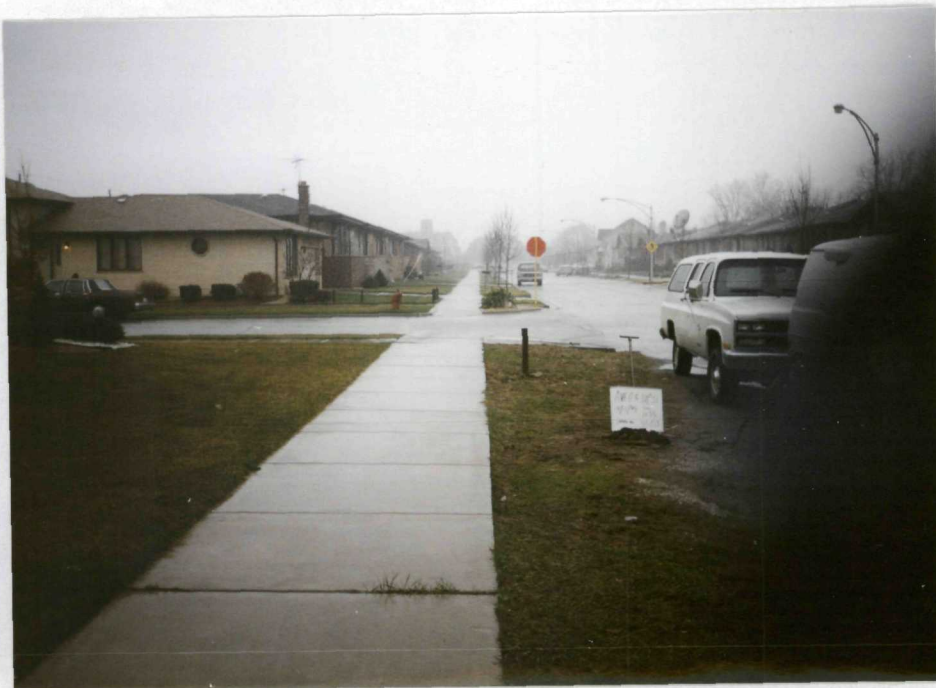
Site: Avenue O and 118th Street  
Proj. #: 71280.102  
Roll: 1 Photo #: 24  
Date: 4-12-94 Time: 1158  
Description: Photo taken facing north,  
showing the sidewalk along the west side of  
Avenue G. The photo also shows a white  
photo placard in an upright position at the  
dirt area between the sidewalk and the  
Avenue G where soil sample SS03 was  
collected. Two white vans, parked on Ave. G,  
are shown.

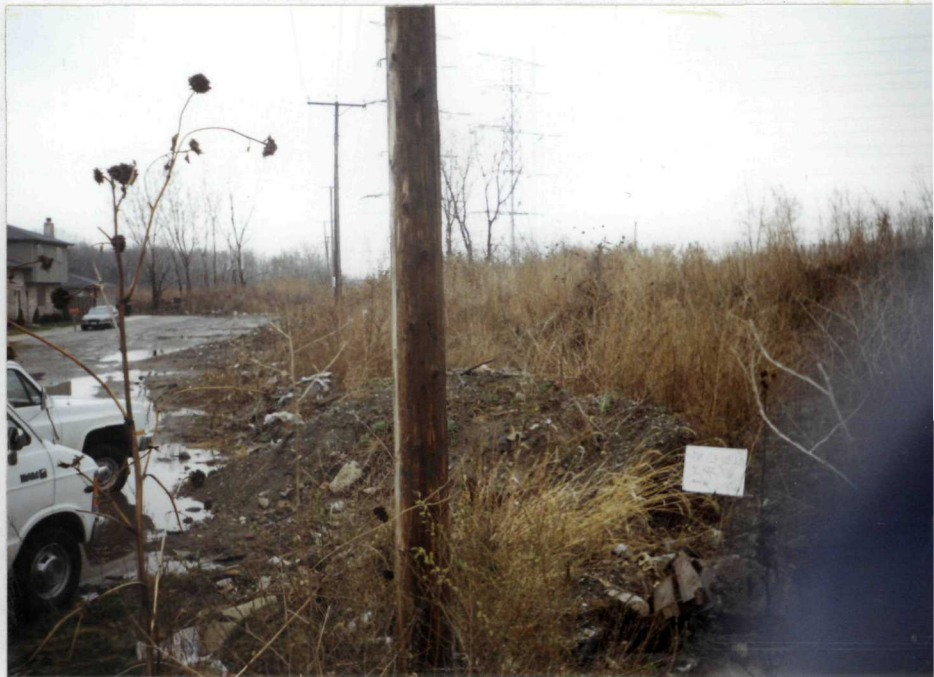
Site: Avenue O and 118th Street  
Proj. #: 71280.102  
Roll: 2 Photo #: 2  
Date: 4-12-94 Time: 1330  
Description: Photo taken facing  
east/southeast showing the heaped dirt that  
soil sample SS09 was collected from on the  
south side of 118th Street. The front ends of  
two white vans appear in the photo and a  
telephone pole is in the foreground.

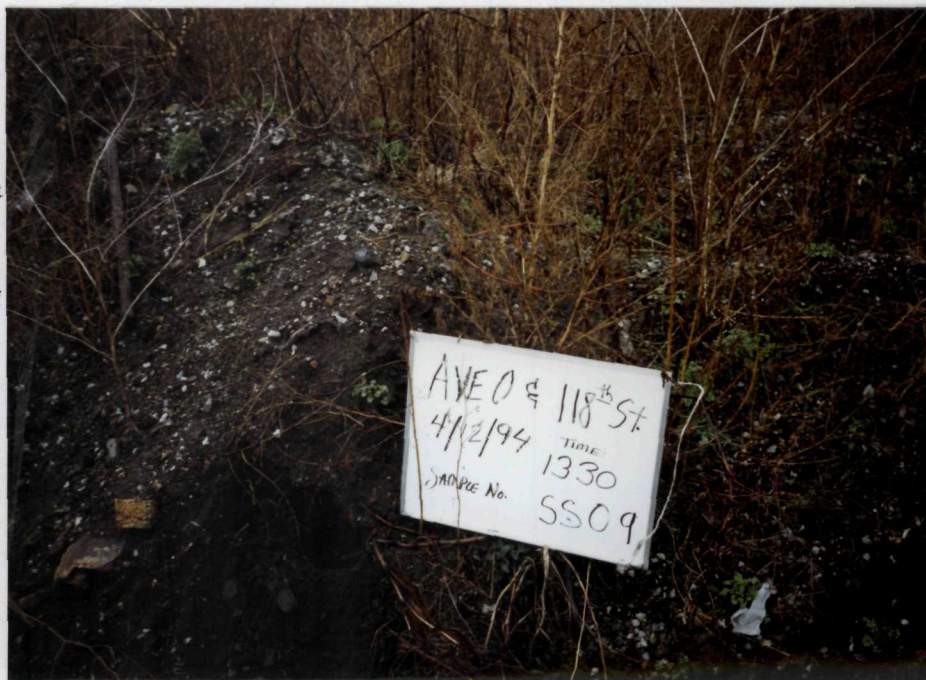
Site: Avenue O and 118th Street  
Proj. #: 71280.102  
Roll: 2 Photo #: 3  
Date: 4-12-94 Time: 1332  
Description: Photo taken facing southeast showing a close-up of the SS09 sampling point. SS09 was collected from a heap of dirt located between the continuous dirt embankment that runs along the south side of 118th Street and the road itself.

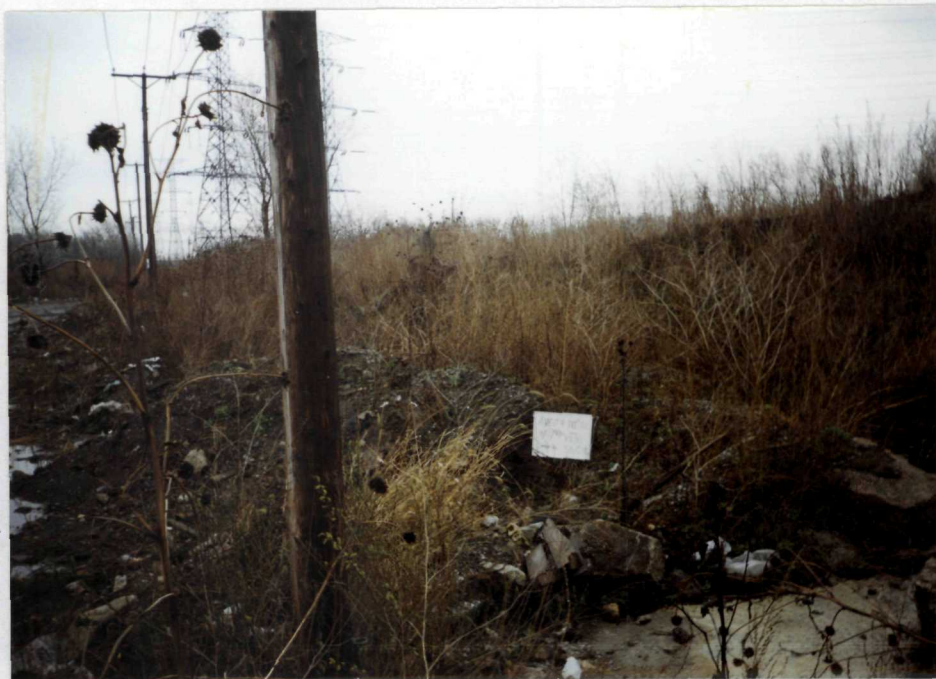
Site: Avenue O and 118th Street  
Proj. #: 71280.102  
Roll: 2 Photo #: 4  
Date: 4-12-94 Time: 1333  
Description: Photo taken facing east/southeast showing the SS09 sampling location. This photo is similar to Photo #2 of Roll #2.

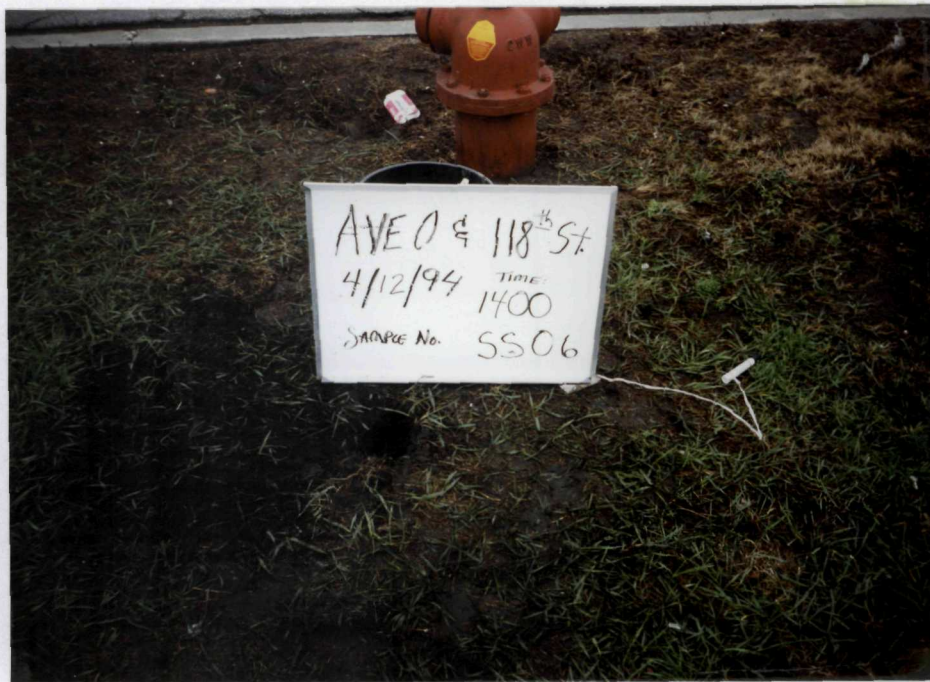
Site: Avenue O and 118th Street  
Proj. #: 71280.102  
Roll: 2 Photo #: 5  
Date: 4-12-94 Time: 1400  
Description: Photo taken facing south,  
showing a close-up of the SS06 sample point.  
There is a fire hydrant in the background,  
behind the photo placard.

Soil samples collected beneath grassy areas between sidewalks and roads with concentrations meeting observed release criteria include SS03, SS05, SS06, and SS07. SS03 contains nine semivolatile organic compounds ranging from 1.6 to 16 mg/kg. SS05 contains one semivolatile organic constituent at 0.75 mg/kg. SS06 contains a heavy metal at 550 mg/kg.

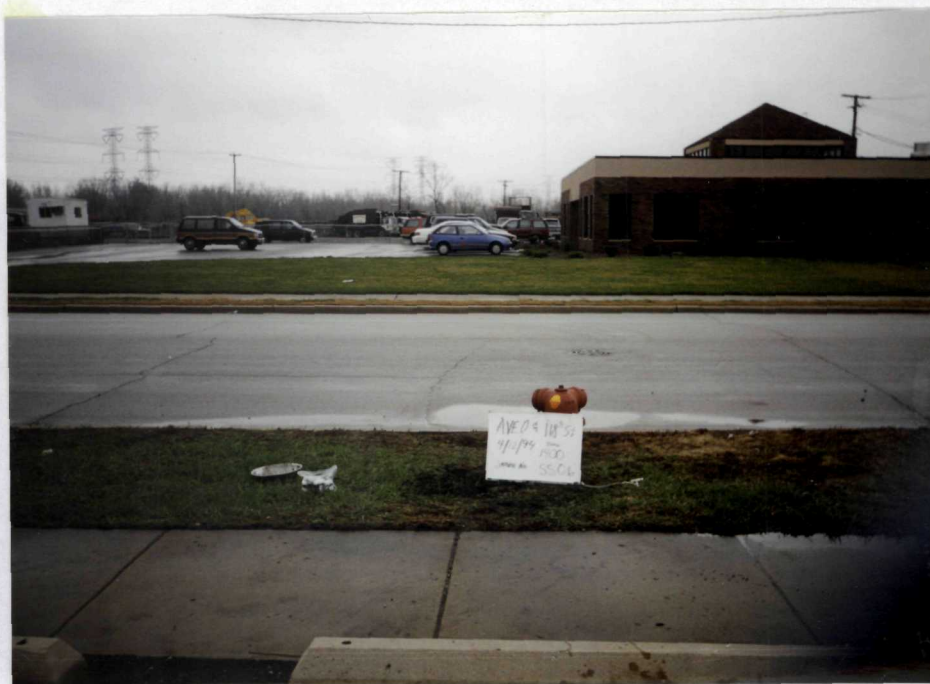
Site: Avenue O and 118th Street  
Proj. #: 71280.102  
Roll: 2 Photo #: 6  
Date: 4-12-94 Time: 1401  
Description: Photo taken facing south,  
showing the SS06 sampling point, with 118th  
Street just beyond the sample point and a  
brick building and parking lot with vehicles in  
the background.

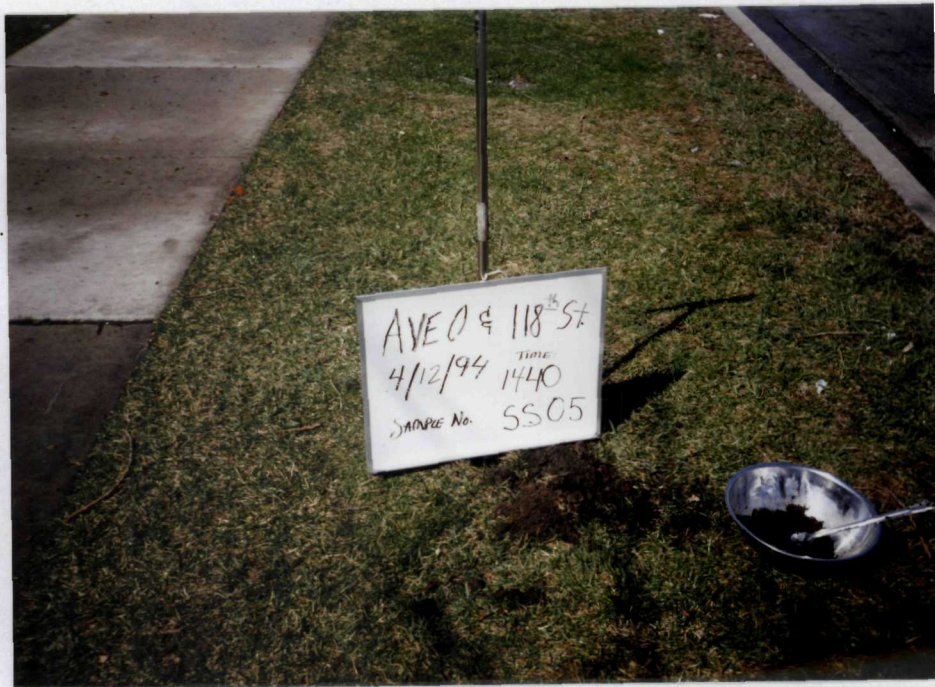
Site: Avenue O and 118th Street  
Proj. #: 71280.102  
Roll: 2 Photo #: 7  
Date: 4-12-94 Time: 1455  
Description: Photo taken facing north,  
showing a close-up of the SS05 sample  
location. A photo placard and sample bowl  
and spoon are in the foreground of the photo.

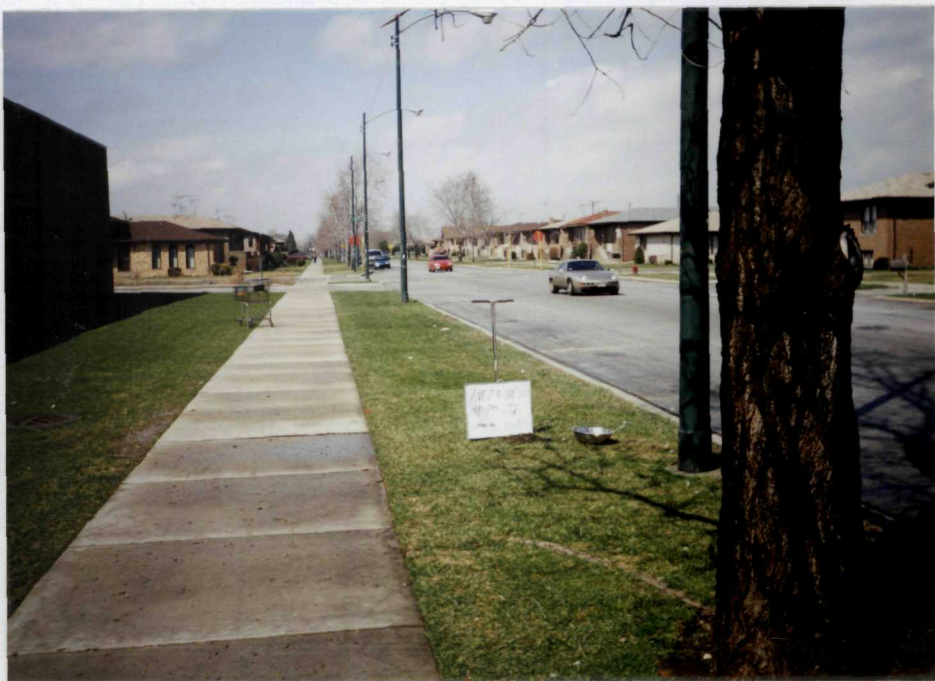
Site: Avenue O and 118th Street  
Proj. #: 71280.102  
Roll: 2 Photo #: 8  
Date: 4-12-94 Time: 1456  
Description: Photo taken facing north  
showing the grassy area between the sidewalk  
and Ewing Avenue where SS05 was collected.

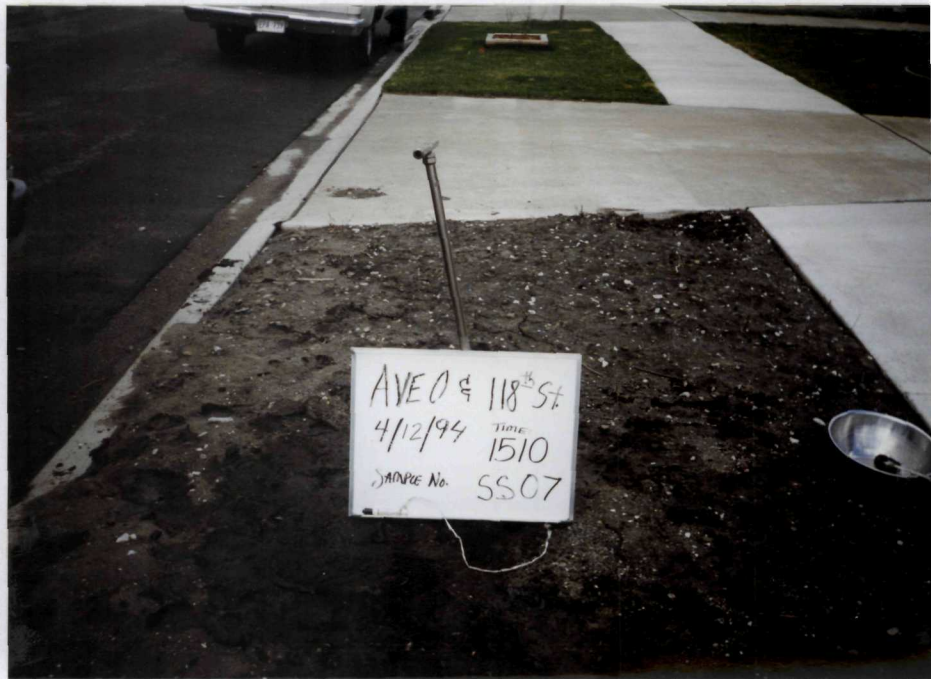
Site: Avenue O and 118th Street  
 Proj. #: 71280.102  
 Roll: 2 Photo #: 9  
 Date: 4-12-94 Time: 1510  
 Description: Photo taken facing north,  
 showing a close-up of the SS07 sample  
 location. SS07 was collected from a dirt area  
 between the sidewalk and Avenue J (on the  
 east side of Ave. J).

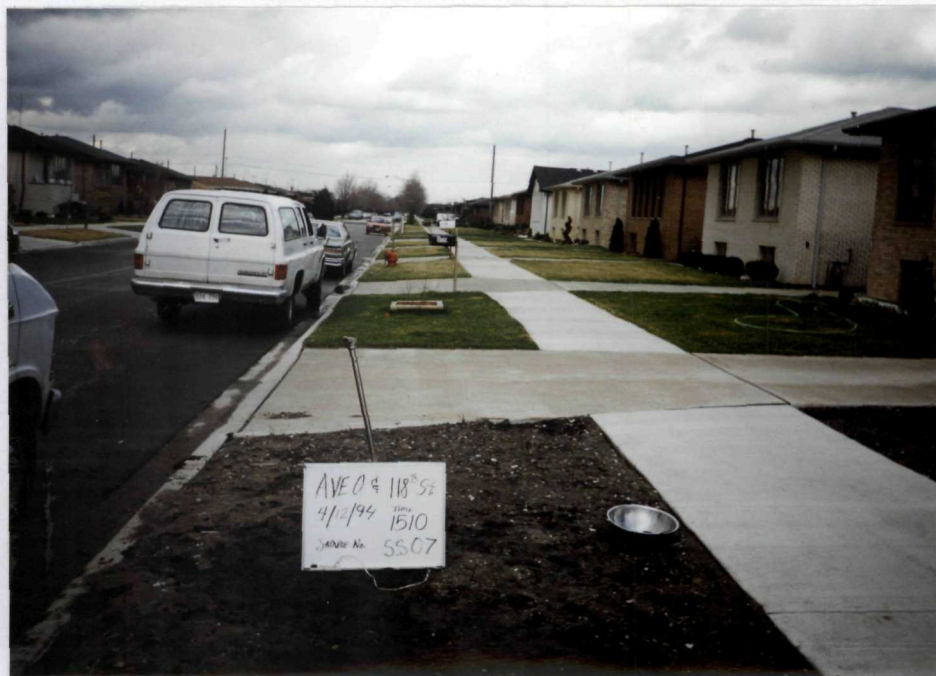
Site: Avenue O and 118th Street  
 Proj. #: 71280.102  
 Roll: 2 Photo #: 10  
 Date: 4-12-94 Time: 1511  
 Description: Photo taken facing north,  
 showing the SS07 sample location. There are  
 residential units, sidewalks, and vehicles  
 parked along the east side of Avenue J in the  
 photo.

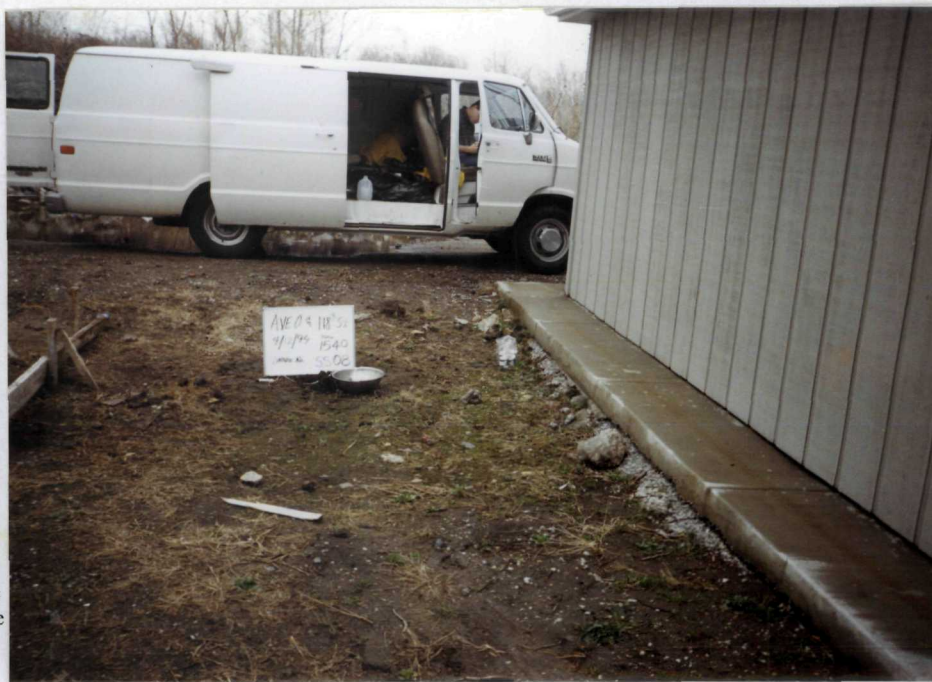
Site: Avenue O and 118th Street  
 Proj. #: 71280.102  
 Roll: 2 Photo #: 12  
 Date: 4-12-94 Time: 1541  
 Description: Photo taken facing east, showing the SS08 sample location in the backyard of an onsite residential unit. In the background, a white van is parked on Avenue H, east of the residence. A garage is shown, in the photo, on the right (south).
